EVALUATION OF
CRACKED BRIDGE DECKS TREATED
WITH VARIOUS
HIGH MOLECULAR WEIGHT
METHACRYLATE RESINS
FOR THE
MONTANA DEPARTMENT OF TRANSPORTATION
WJE NO. 981825

July 27, 2000

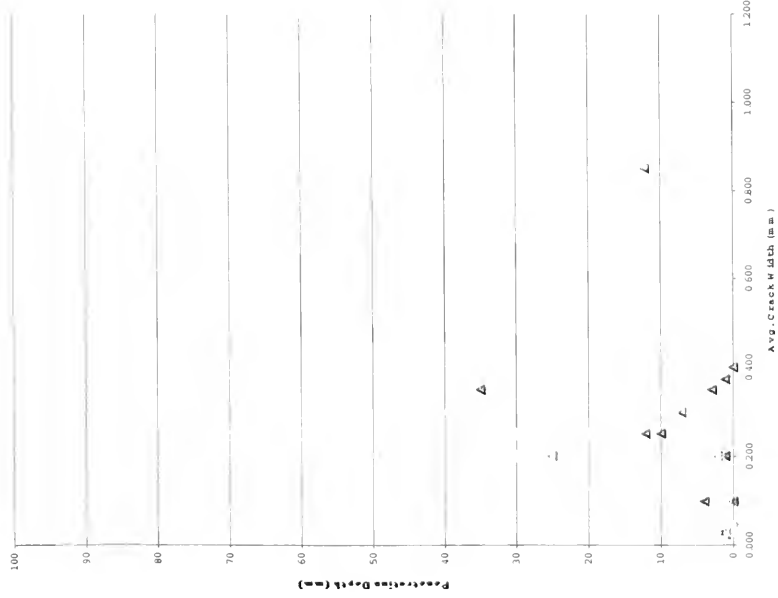
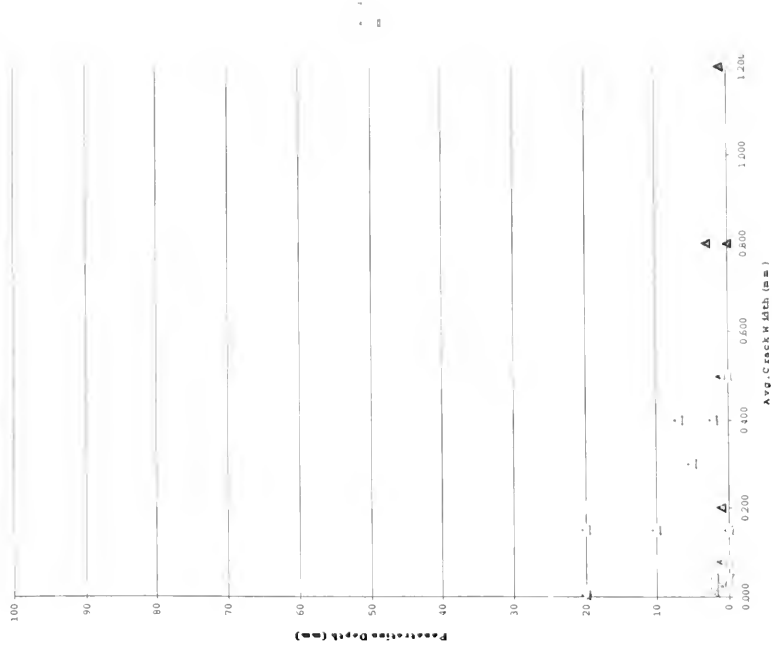
determined to be high (30 percent) elongation resins. Transpo T70-10, Sika Pronto 19, and Transpo T70-X are assumed to be low (less than 10 percent) elongation resins. The elongation of the resins supplied by Harris Specialty Chemicals and American Concrete Systems is uncertain. Table 5 summarizes the range of resin penetration for the various resins. Figure 6 shows plots of the range of resin penetration for various crack widths. Both high and low elongation resin types had a large range of penetration depths. Figure 7 shows the range of resin penetration versus crack widths for all cores and resins. Generally, penetration was deeper in cracks with widths less than 0.4mm than for cracks with widths of 0.5mm to 1.2mm. No significant difference in the penetration of high versus low elongation resins was seen in this study.

Figure 6 – Depth of penetration versus crack width for high and low elongation resins

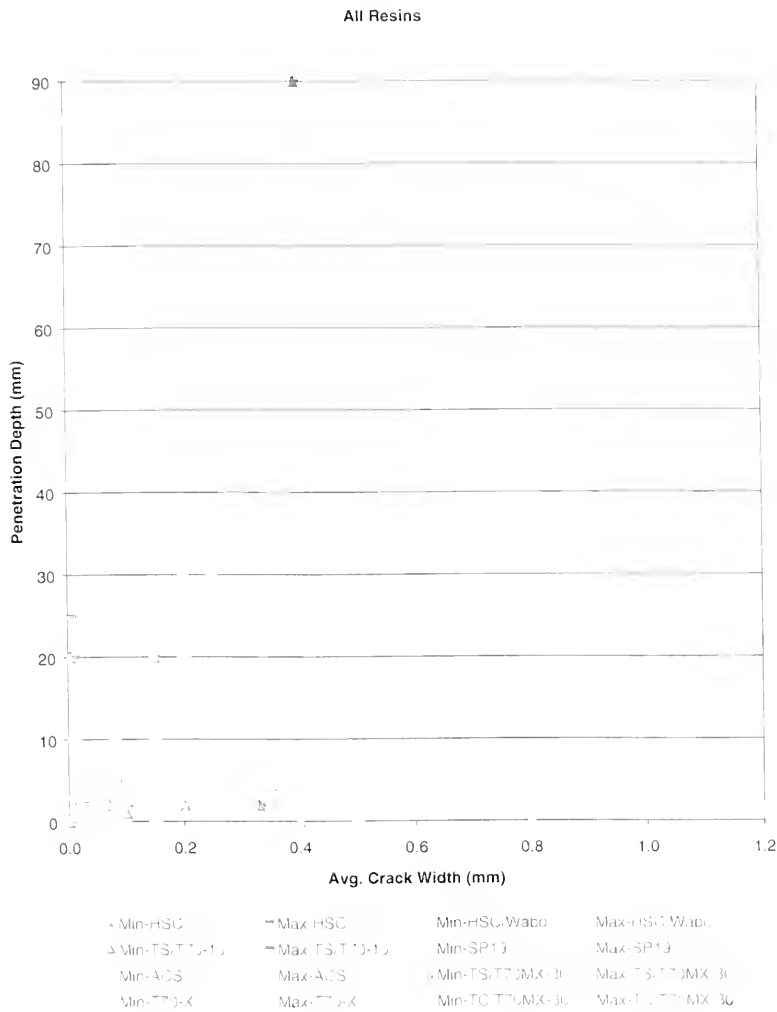
Figure 7 – Depth of penetration versus crack width for all cores
